Housing the Workers

Early London County Council Housing

28 – Mare Street, Hackney

Mare Street Widening Scheme, Hackney

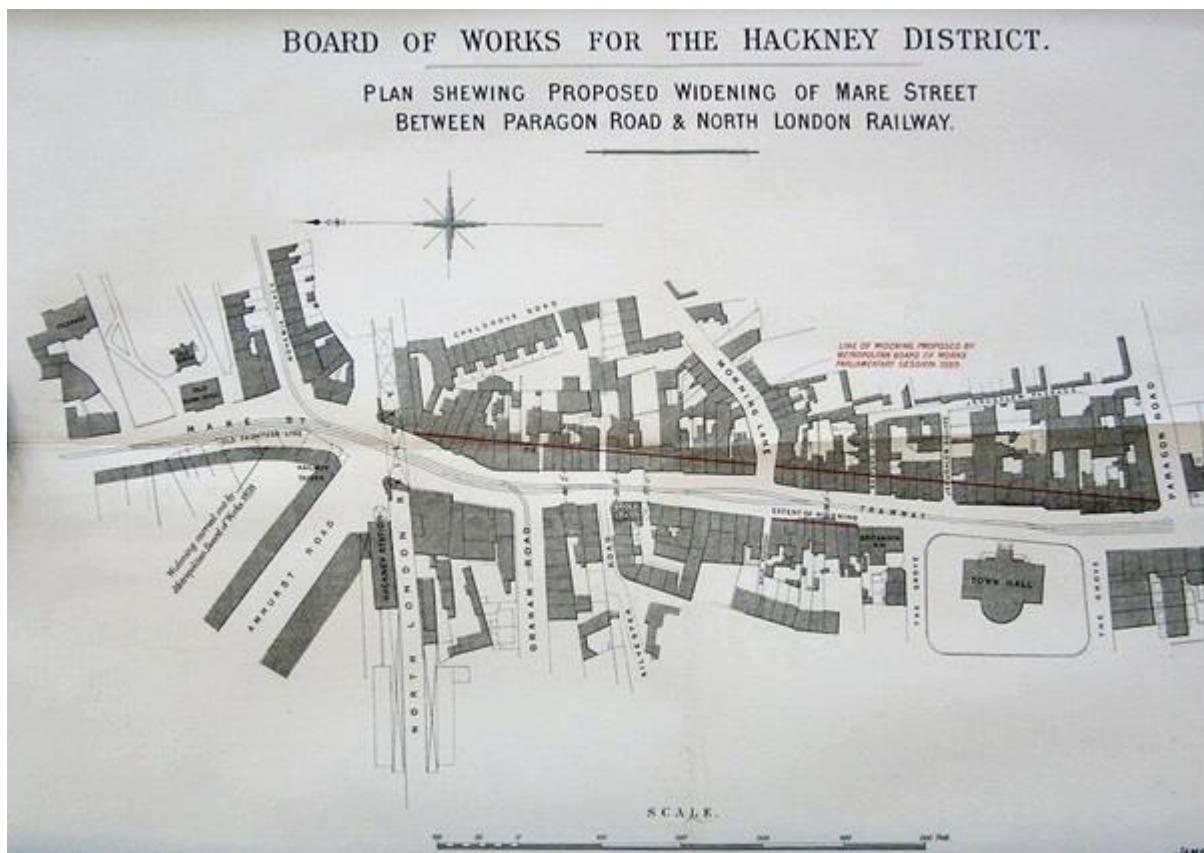
Fig. 1: The original plan to widen Mare Street, 1900 (LCC ref: LCC/CL/IMP/1/127)

Looking at the line on the map above one would not imagine a large number of working-classes to be displaced. Much street-front property along the main thoroughfares would not consist of typical homes for the working classes, but the clearance scheme produced a surprising number of displaced persons. The Council minutes of the time state 486 were to be displaced but later Council publications state 526 (probably based on those actually displaced by the clearance). The reason both these figures are high for such a simple street widening is that it was not just the street front properties that were demolished, but also many of the properties behind, and particularly those between Morning Lane and Paragon Road. Fig. 2 and Fig. 3 below are photographs of Jerusalem Square and Jerusalem Passage, opposite the Town Hall, taken in 1899. The narrowness of part of Jerusalem Passage is not obvious from the plans above.

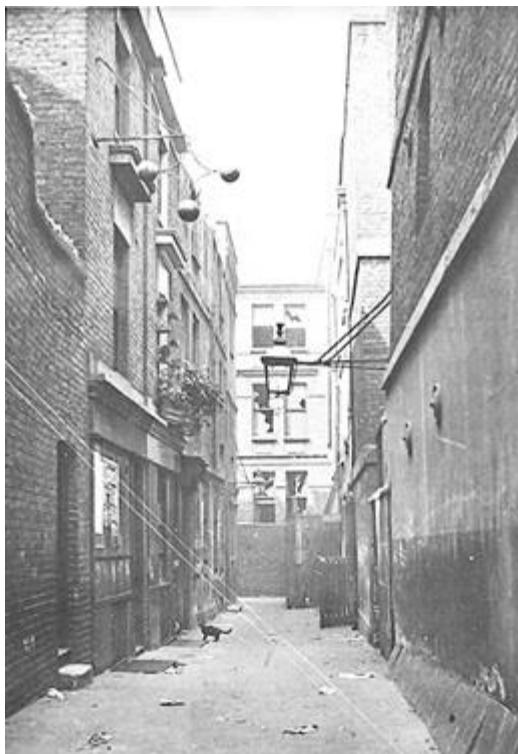
Fig. 2: Jerusalem Square, 1899 (LMA ref: SC/PHL/01/086)

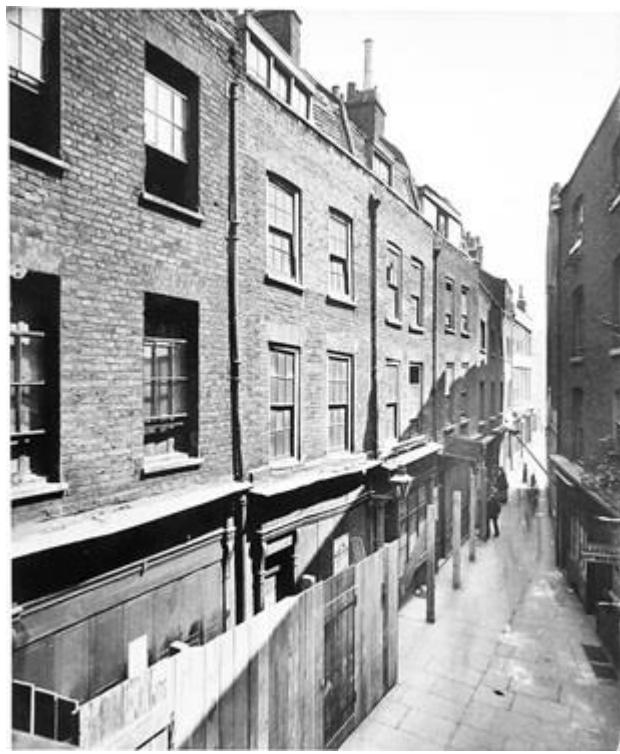
Fig. 3: Jerusalem Passage, 1899 (LMA ref: SC/PHL/01/086)

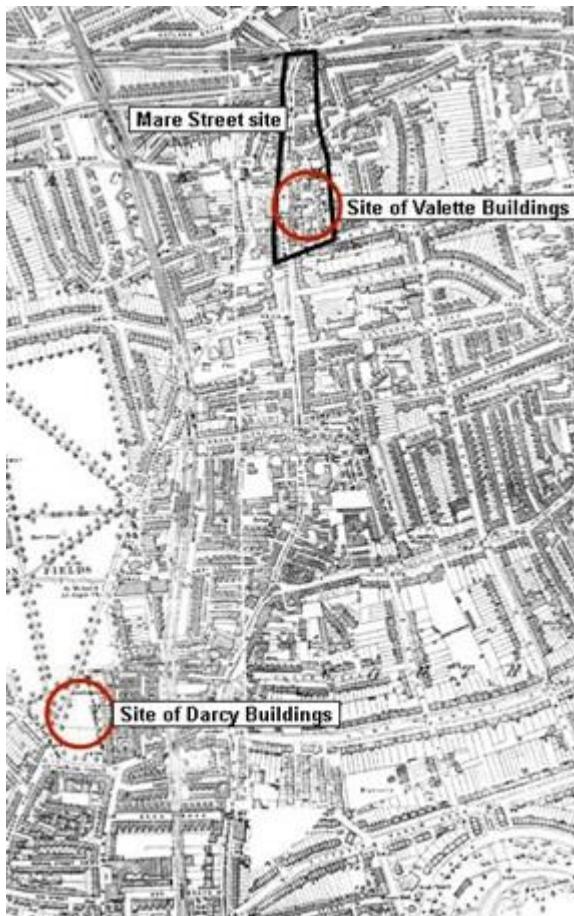
Fig. 4: Mare Street site from 1896 OS Map

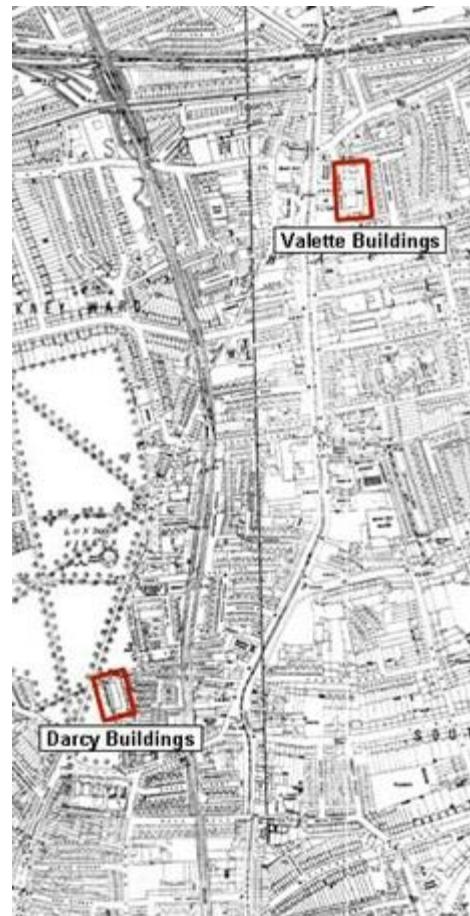
Fig. 5: Mare Street site from 1916 OS Map

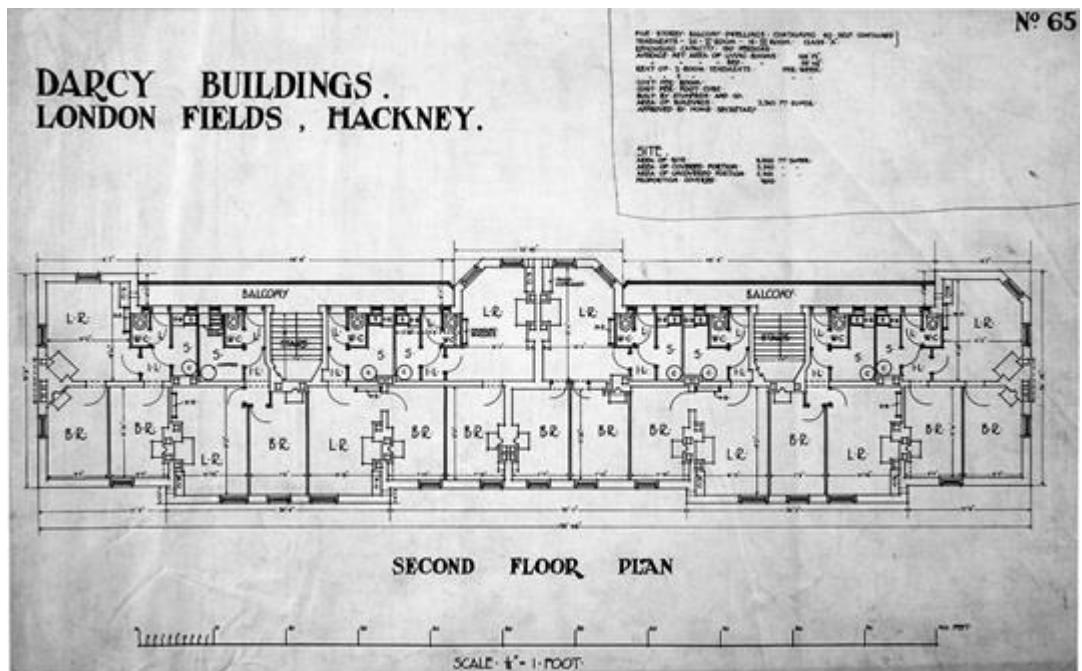
Fig. 6: Darcy Buildings floor plan (LMA ref: LCC/AR/HS/03/059)

As can be seen from the floor plans below, Darcy Buildings show no particular architectural features apart from a neatness in placing the WCs and sculleries along the walkway side which resulted in most of the living and bedrooms having views across London Fields. The plans for Valette Buildings show a refreshing return to thick party walls and generously proportioned rooms.

The average room size in Darcy Buildings is slightly about the minimum standard of 144 and 96 sq. ft. respectively for living and bedrooms. The room sizes in Valette buildings are a little more generous.

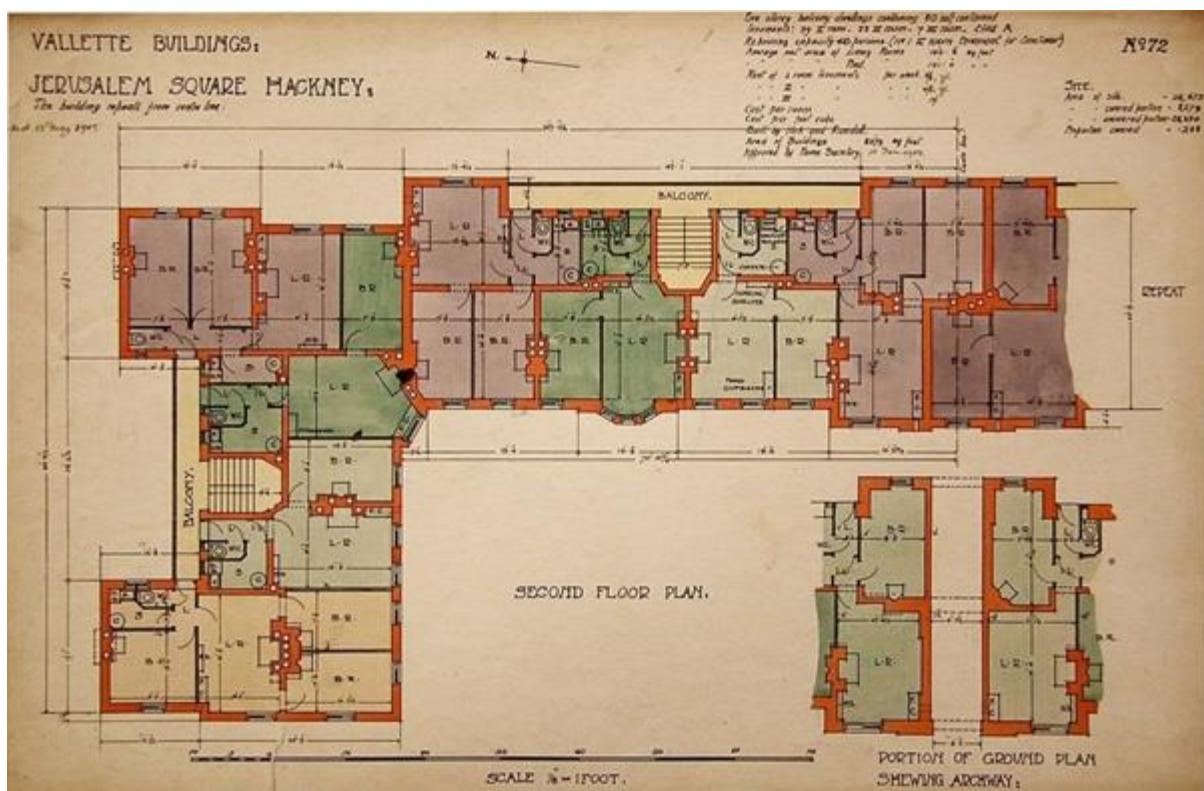
Fig. 7: Valette Buildings floor plan (LMA ref: LCC/AR/HS/03/057)

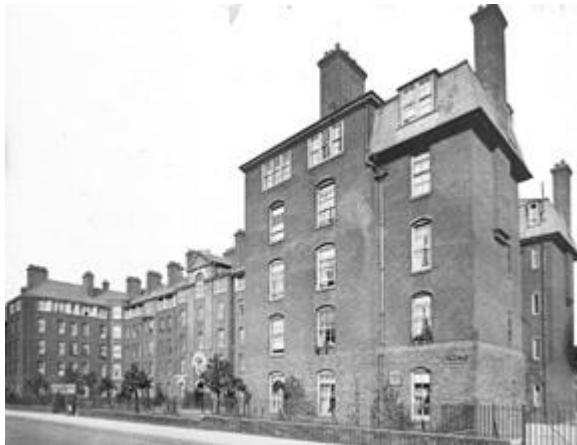
Fig. 8: Front view of Valette Buildings, 1907 (LMA ref: SC/PHL/02/0883)

The reason for the lower quality of Darcy Buildings has to be the requirement to try and avoid an annual charge on the rates with the lower rents prevalent in that area reducing the potential annual income. This is despite the site itself being a particularly pleasant one with the building overlooking (and still overlooking) a large public park. The architects sensibly placed the balconies (the front of the building) facing the opposite way leaving the living and bedrooms to face across the park. The Valette Buildings to the north are quite impressive to look at, particularly from the front.

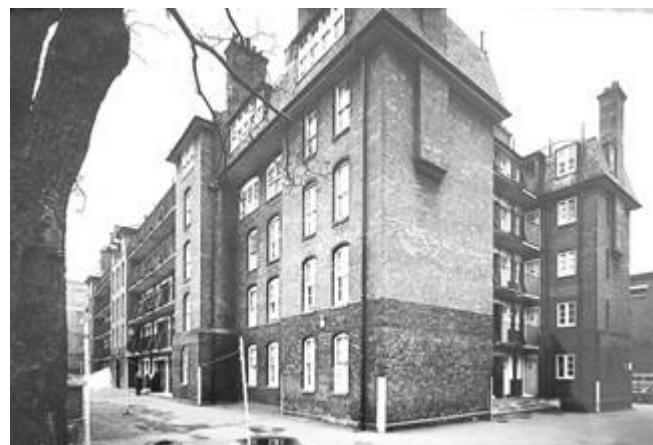
Fig. 9: Rear view of Valette Buildings, 1960s (LMA ref: SC/PHL/02/0883)

The rear of Valette Buildings was damaged in WW2 when the building behind that was badly damaged, and is another example of the strength of the LCC methods of construction. The buildings in 2009 look in good condition and the surrounding area clean and well kept.

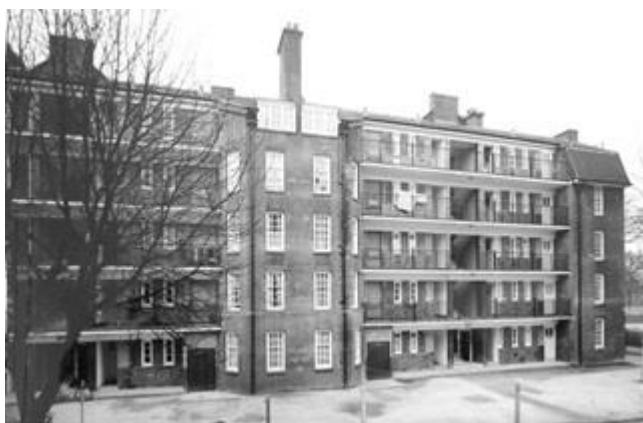
Fig. 10: Walkways of Darcy Buildings facing away from London Fields, 1966 (LMA ref: SC/PHL/02/0885)

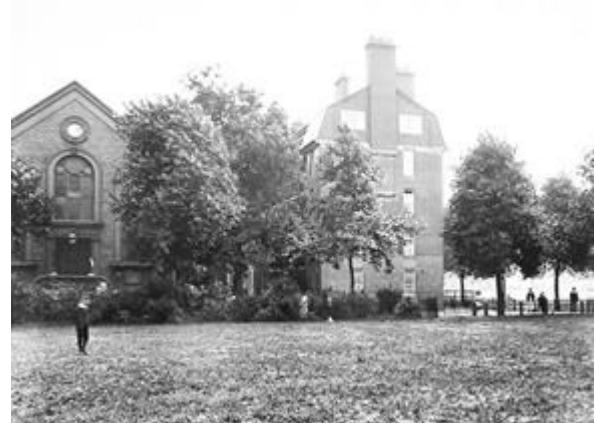
Fig. 11: Interesting view of Darcy Buildings from 1907 illustrating the expanse of London Fields to the distant right. (LMA ref: SC/PHL/02/0825-17)

Darcy Buildings was erected by Messrs Stimpson & Son between Mar 1903 and July 1904 and accommodated 190 persons. Valette Buildings were erected by Messrs Kirk and Randall between November 1903 and May 1905 and accommodated 416 persons. The total capacity was 606 persons which exceeds, by a wide margin, the requirement to re-house 526 persons.

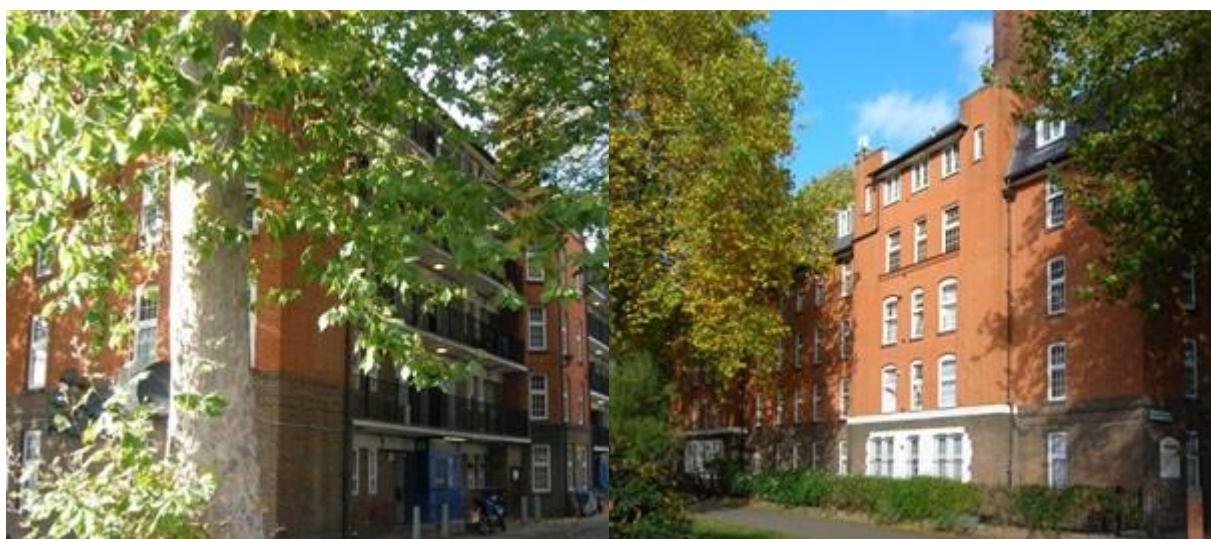
Fig. 12: Front of Darcy Buildings, 2009

Fig. 13: Rear of Darcy Buildings looking onto London Fields, 2009

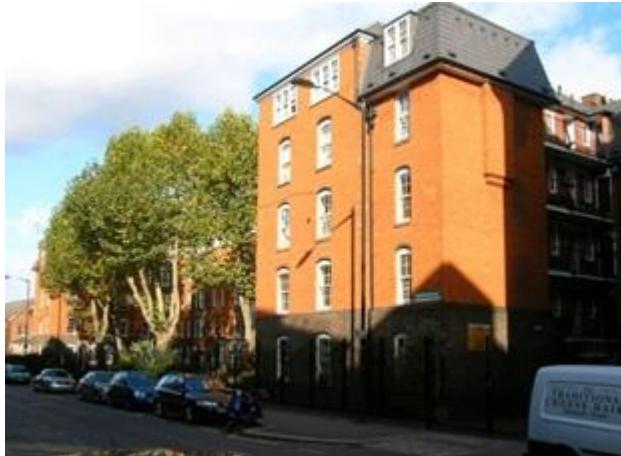
Fig. 14: Valette front, 2009

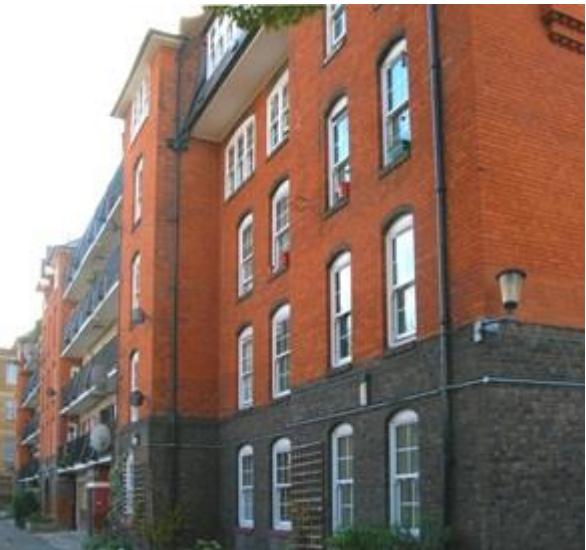
Fig. 15: Valette rear, 2009
